Inspection Report

Property Address:
23-4627 Sharp Terrace
Saanich British Columbia

Victoria Home Inspections

Date: 2022-05-13	Time:	Report ID: VHI-3301
Property: 23-4627 Sharp Terrace Saanich British Columbia	Customer: Mr. Quaid King	Real Estate Professional:

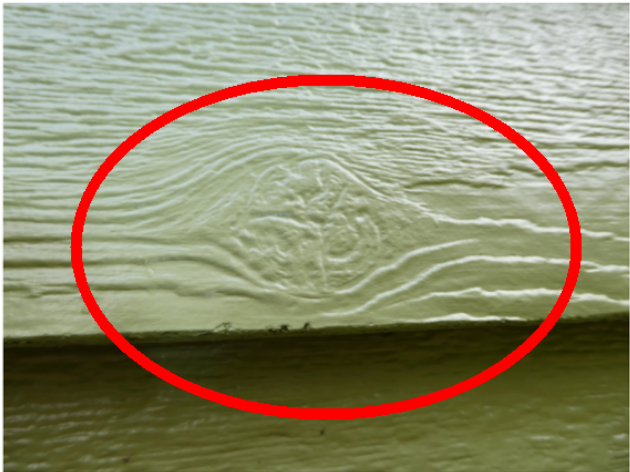
2.0 Item 1(Picture)

LP Inner Seal siding can be identified by the classic LP knot that is embossed into the siding – see attached photo. The timing is a little fuzzy, but to my understanding, LP stopped making Inner Seal siding around 1996, and they started making a similar and improved product called SmartSide starting around 2000. You cannot distinguish LP's Inner Seal product from the newer SmartSide product once it is installed....at least I can't. Unfortunately, the knots are the same and the siding looks the same. The only way I can make a guess at distinguishing the two sidings is the age in which they were installed. Roughly 2000's and newer should be SmartSide where anything from the 1990's should be Inner Seal. This leaves late 1990's in something of a gray area.

Classic LP knot

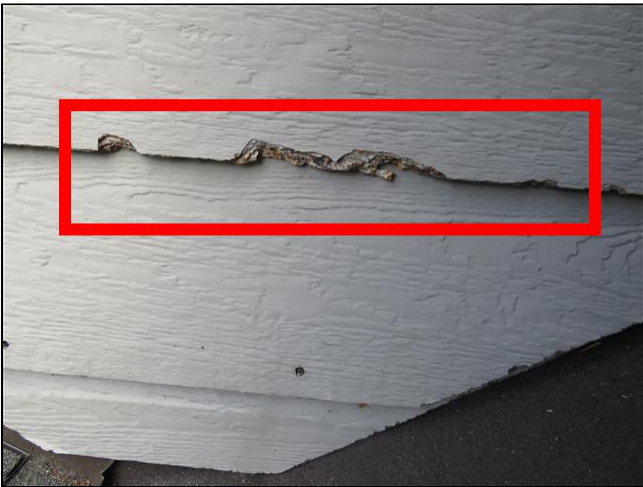
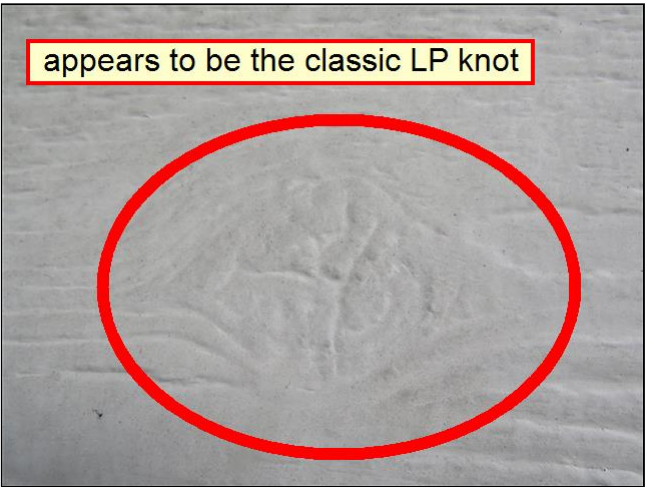
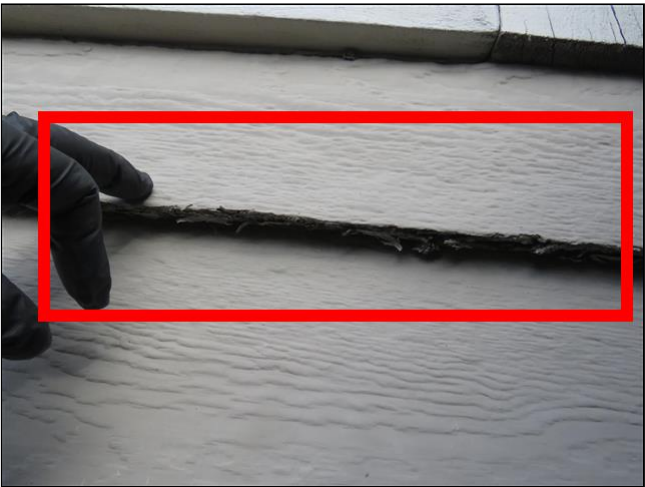
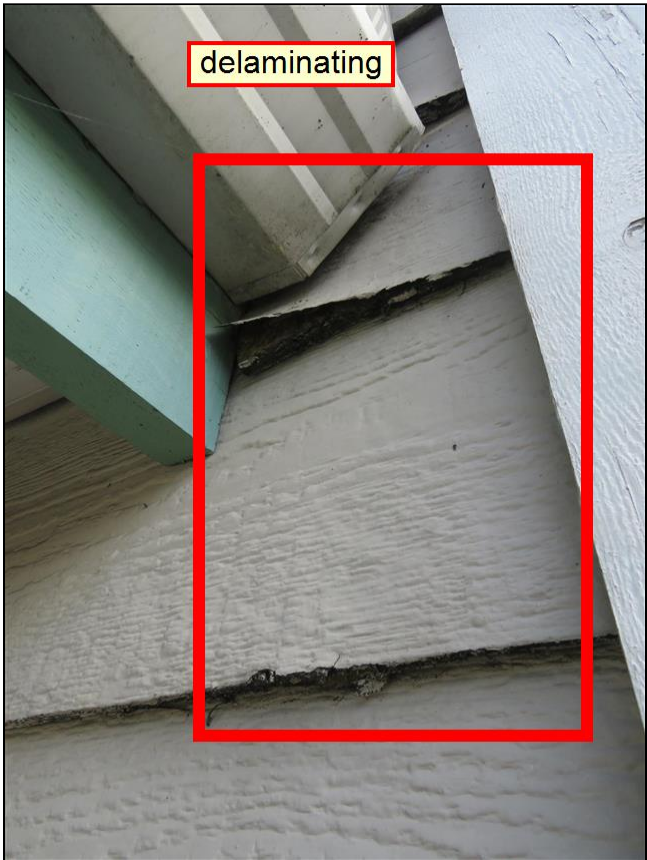
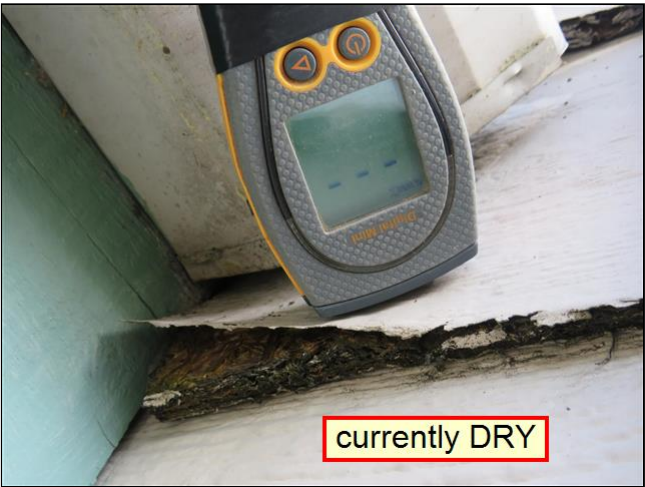
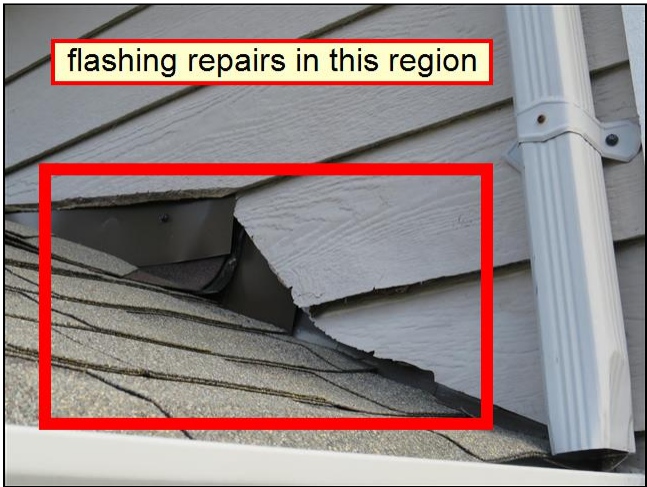
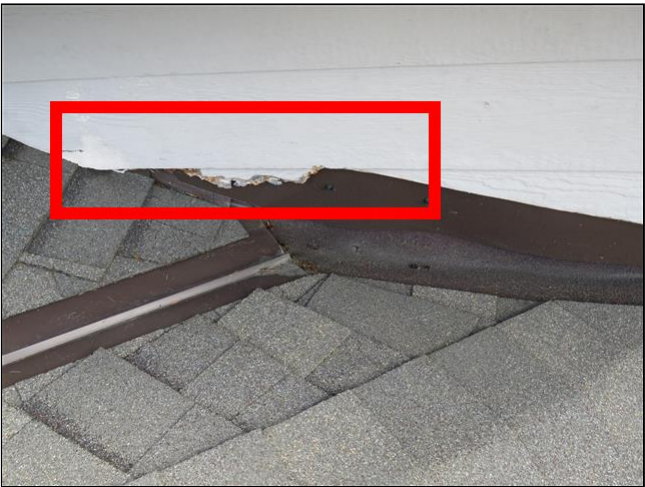
LP Inner Seal suffers has been known to fail prematurely and was the subject of a now settled class action lawsuit. It fails where it is exposed to the weather, and the lap siding is most vulnerable along the bottom edges where water absorption, swelling, and delamination can occur. Lack of maintenance, exposure, and poor installation all contribute for premature failure of the OSB siding. Online literature states that once the product failed and swelled, the deterioration could not be reversed (i.e. painting) and required replacement. The lifespan of the product varies depending on maintenance install and exposure.

Swelling at the edges and delamination was observed in several areas on the home and in the townhouse complex.

Recommend contacting the strata prior to closing about the type of siding installed to identify their plan moving forward and associated costs for a further in-depth review of the building envelope by a qualified contractor, and repair or replacement of the siding as needed in the future.

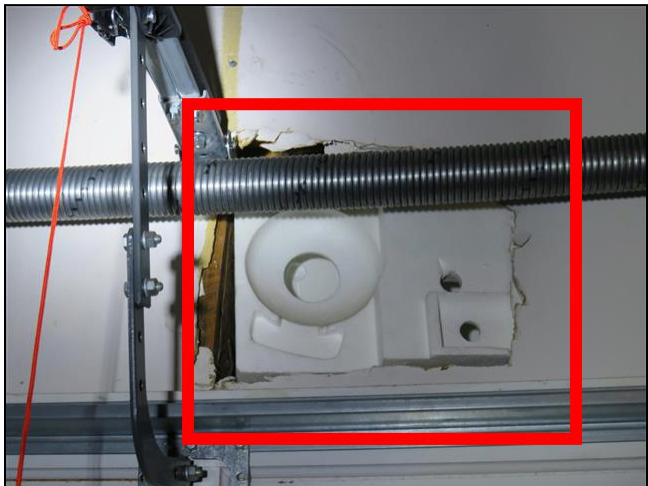
3.1 Item 1(Picture)

The hole in the garage wall above the garage door should be repaired upon move-in to maintain integrity of the fire resistant barrier in the garage.

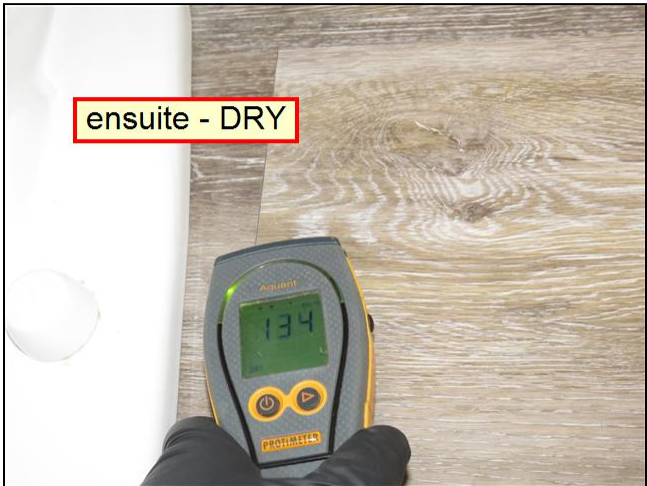
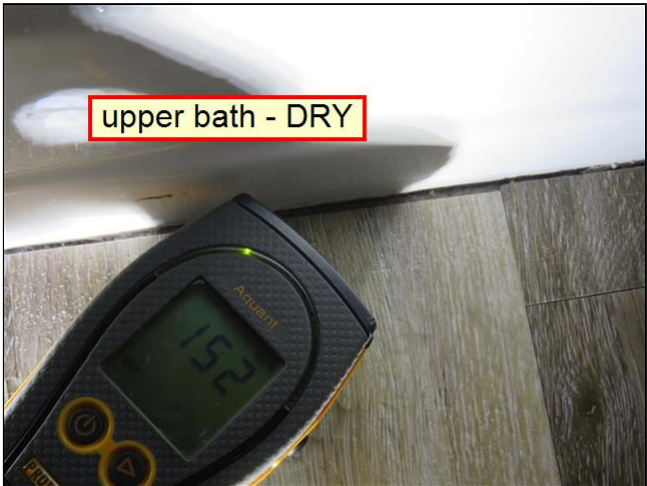
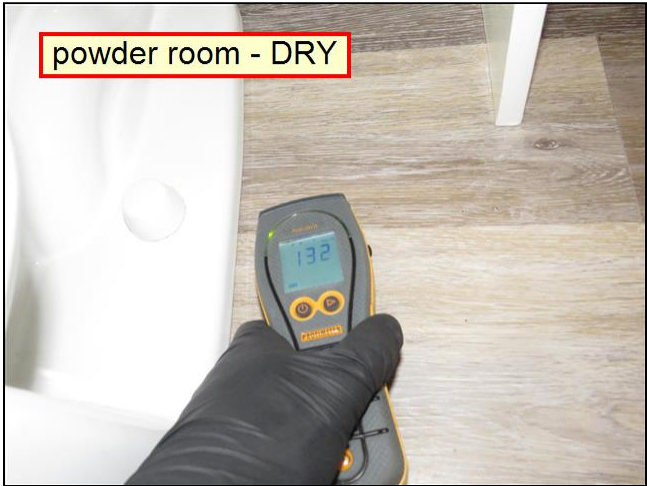
(1) The subfloor near all toilets was tested with a moisture meter to identify leaks from failed wax seals. No elevated moisture levels were detected. This is for your information.

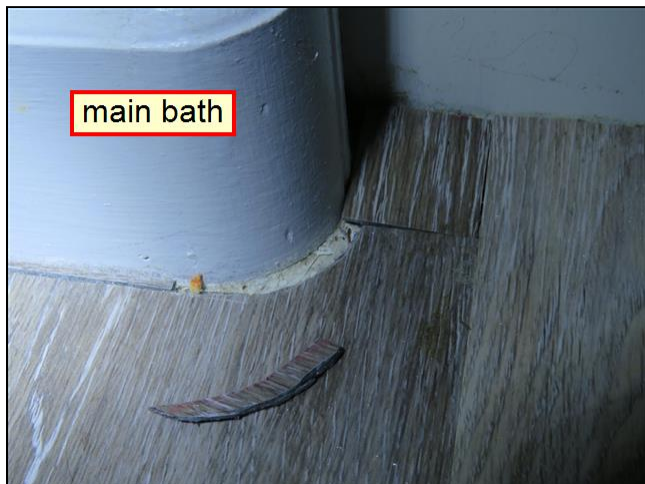
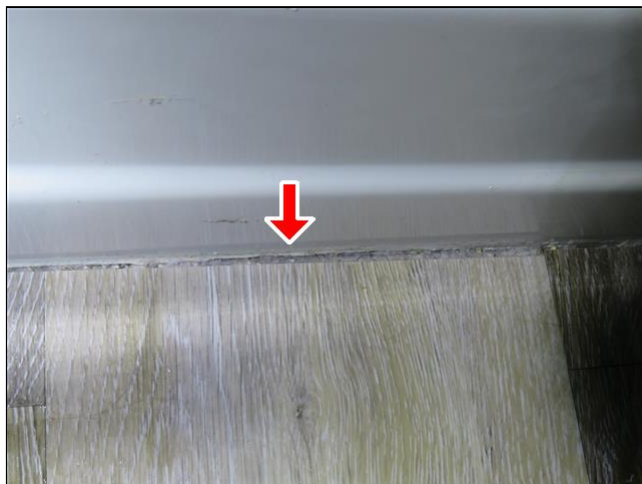
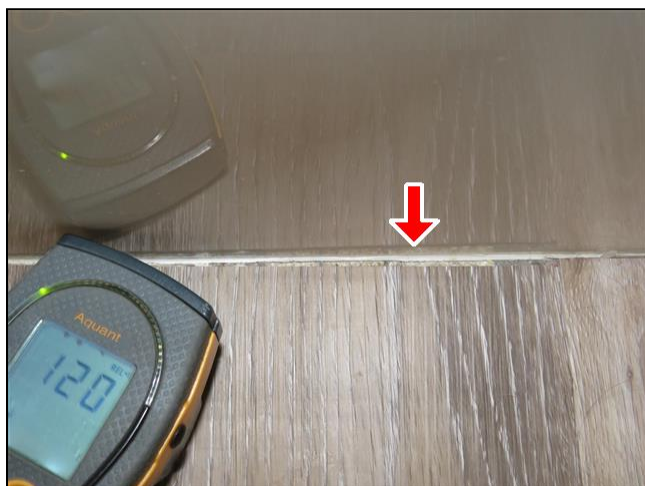
(2) Recommend silicone along the shower/tub and floor to prevent water ingress into the subfloor in the main bath and en-suite. Some of the flooring is loose. Secure, as needed.

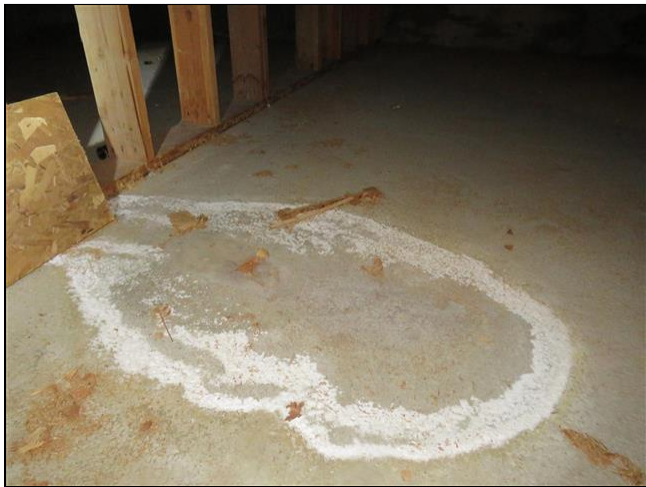
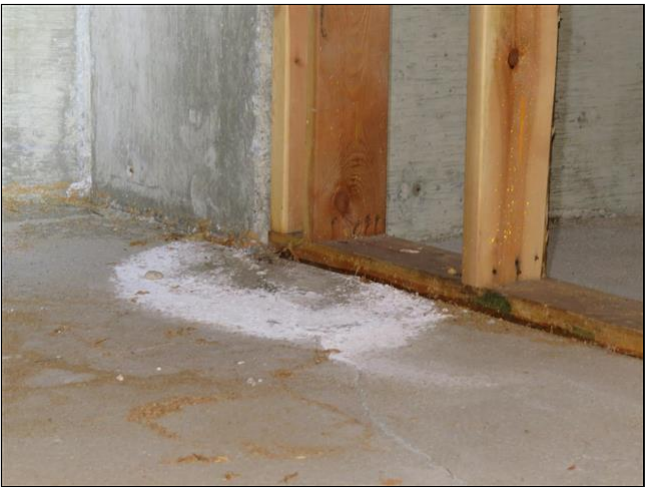
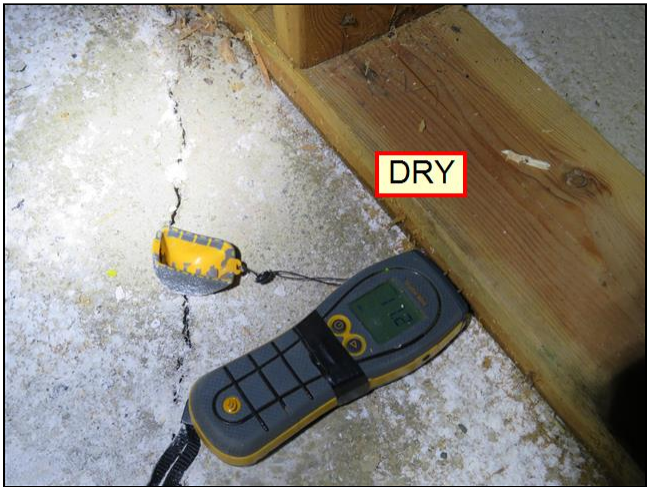
White efflorescence (powder substance) in the crawlspace indicates moisture is in contact with the concrete slab. This does not necessarily indicate that intrusion will occur.. Efflorescence is found on many homes without water intrusion occurring inside the home. The framing adjacent to the efflorescence was dry when tested. Monitor with time and repair as needed.

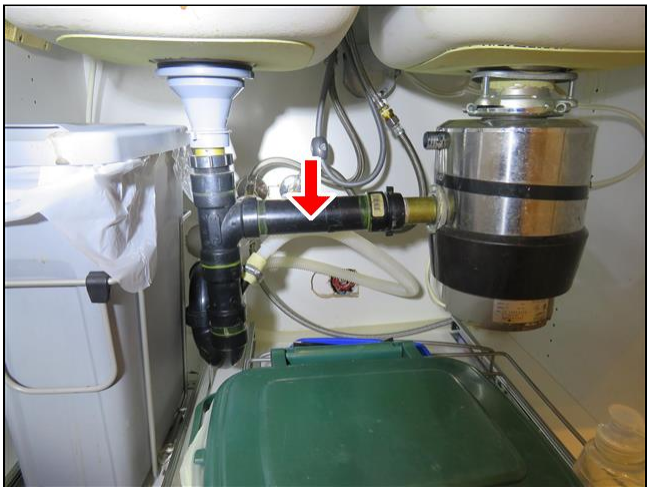
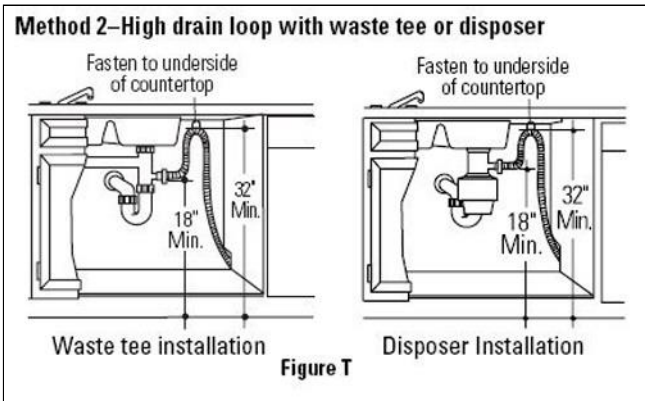
The dishwasher drain does not have a 'high loop' installed in the drain. A high loop is recommended in the near term to prevent potential backflow contamination of the dishwasher.

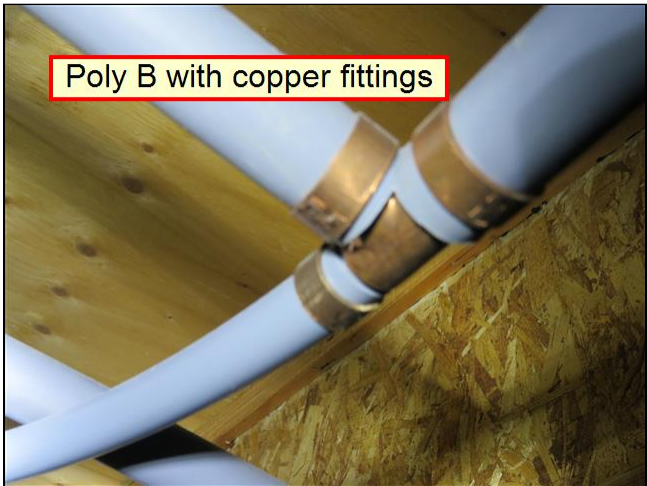
6.1 Item 1(Picture)

Poly B supply piping with copper fittings was observed in the crawlspace. Poly B has a history of failing. Consult a plumber regarding the condition of the piping and possible replacement prior to removing conditions. In addition, there may be possible insurance issues; consult with your insurance provider. Re-piping can be expensive. Water leaks can damage contents, materials, and structure.

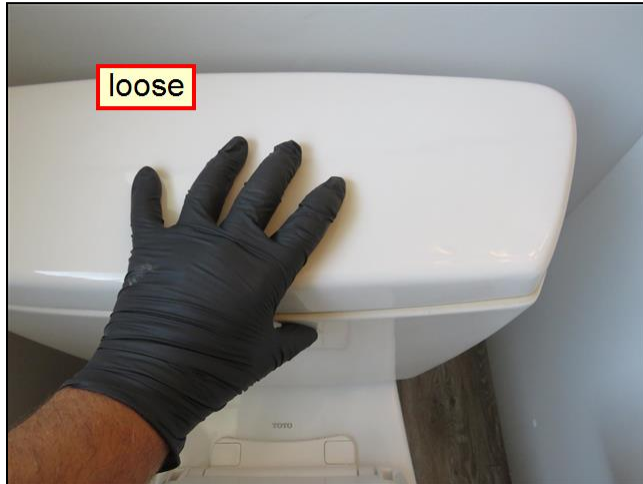
6.1 Item 2(Picture)

(2) The toilet tank in the main bath upstairs is loose from the bowl. Recommend the connection bolts be tightened as needed before leaks or failure occurs.

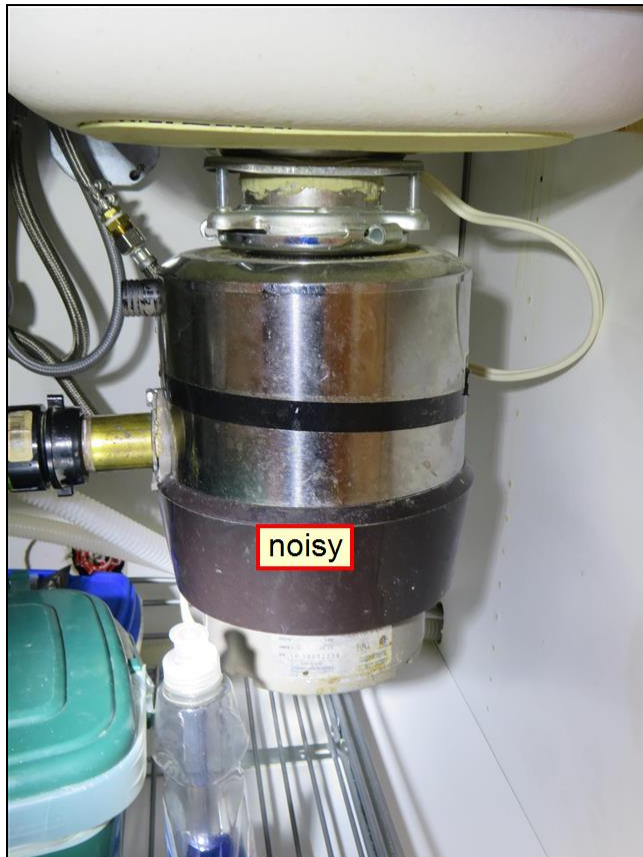
6.1 Item 3(Picture)

(3) The garburator was noisy when tested. Recommend it be cleaned, serviced or replaced in the near term before failure occurs.

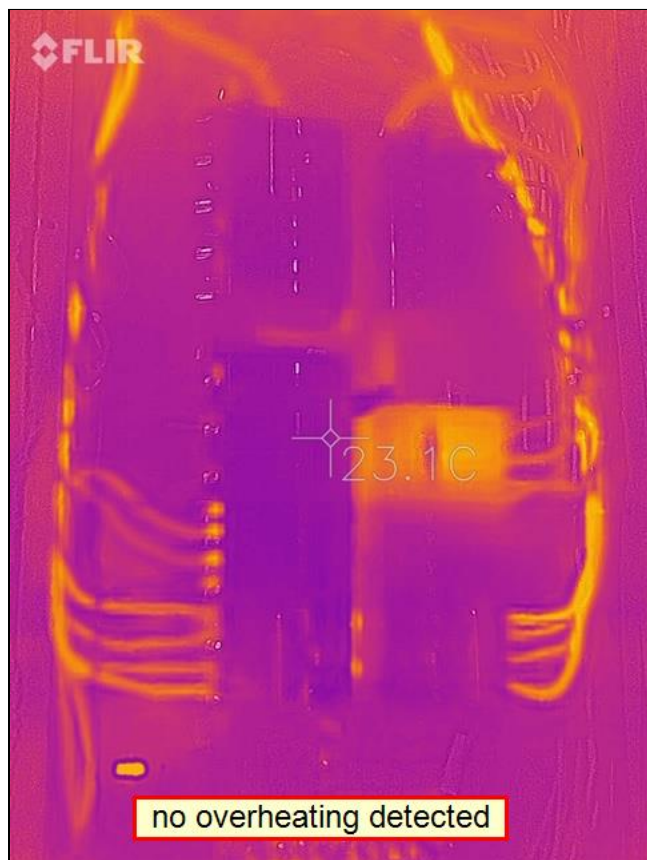
7.1 Item 1(Picture)

The main electrical panel was placed under load by operating the major 240 volt appliances and scanned with an infrared camera. No electrical anomalies were detected.

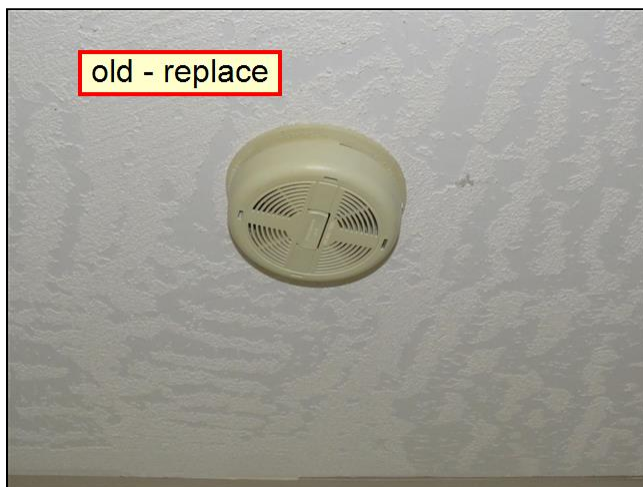
7.7 Item 1(Picture)

Not tested at time of inspection. Smoke detectors over 10 years of age should be replaced upon move in for safety.

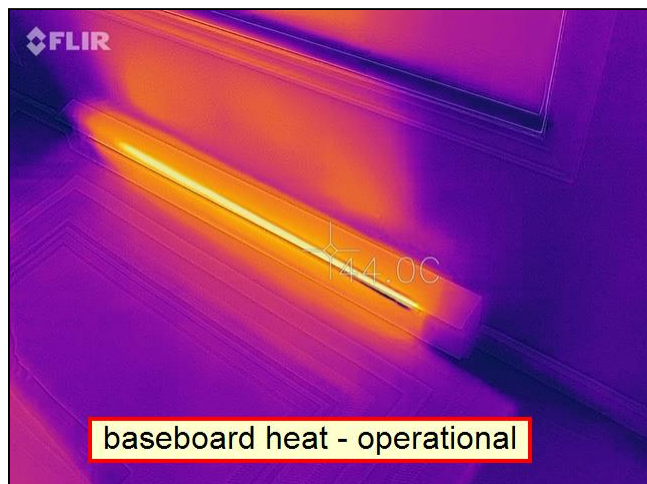
8.1 Item 1(Picture)

The operation of the electric baseboard heat throughout the home was tested with a thermal imaging camera. No deficiencies noted at time of inspection. This is for your information.

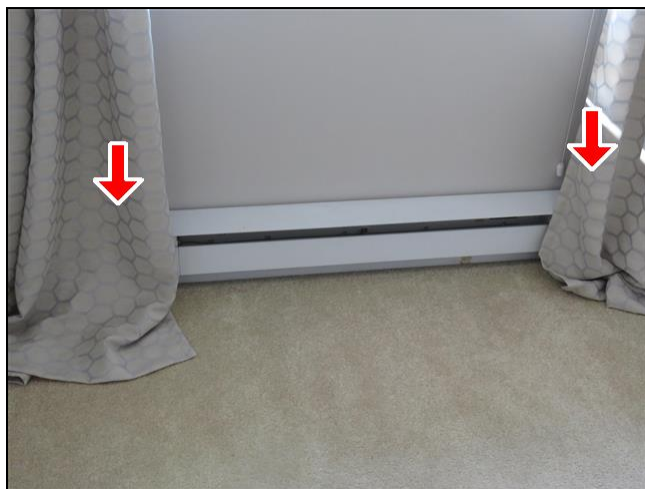
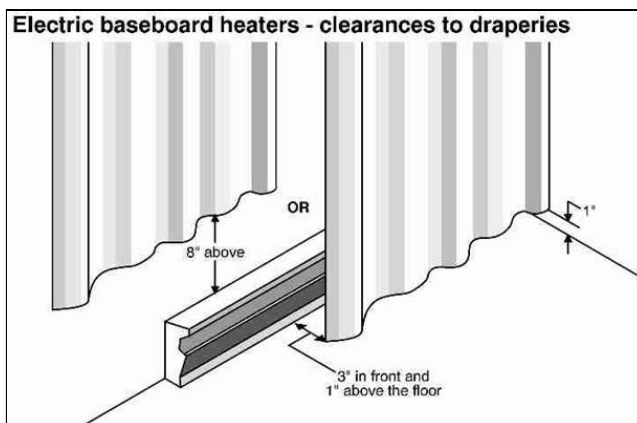
At least three electric baseboard heater have window coverings close to the heating elements. This is a safety issue and should be repaired. Recommend modifying the window coverings as needed prior to use.

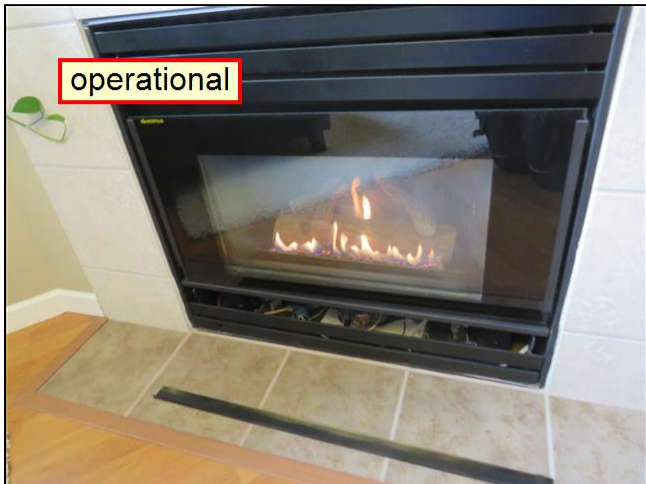
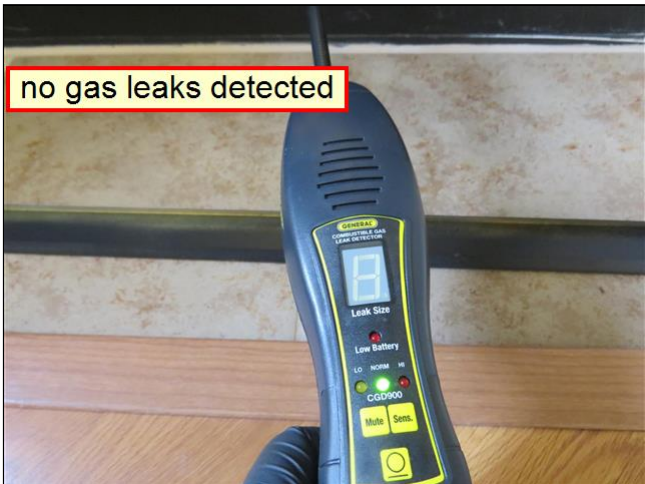
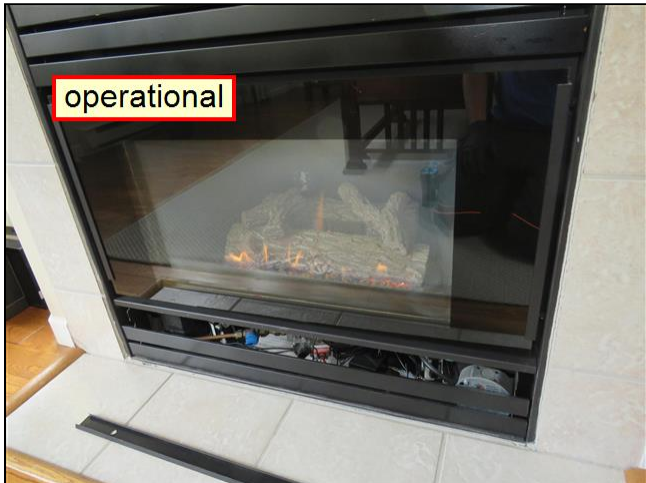
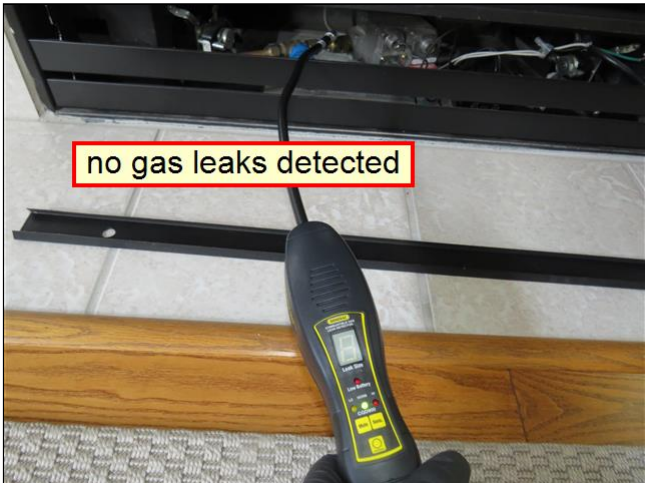
The gas fireplaces responded to the thermostats at time of inspection. No gas leaks were detected at the fireplaces.

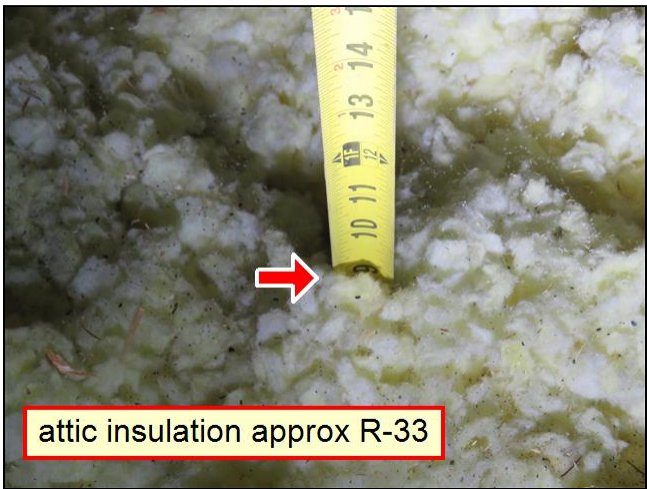
9.0 Item 1(Picture)

The attic insulation thickness is about nine inches thick or just under 33 R-Value. This is for your information.

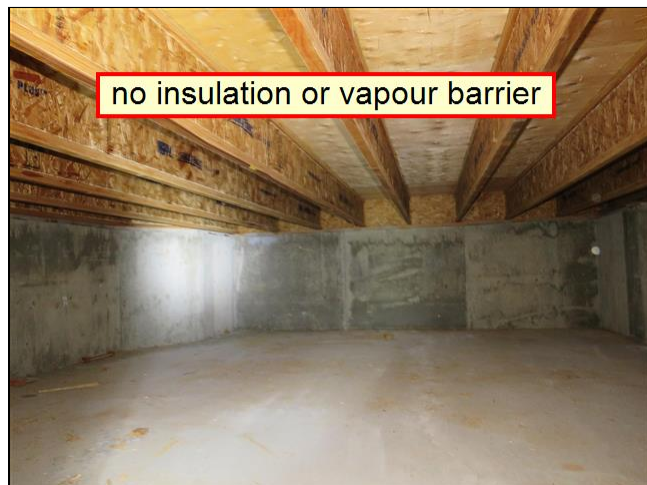
9.1 Item 1(Picture)

The floor system appears to not be insulated. Heat loss and moisture absorption can occur more on this home than one that is properly insulated. Recommend confirming with the strata the presence or absence of exterior insulation on the foundation. Recommend insulation and vapour barrier be added to the interior of the foundation walls if needed by a qualified contractor.
