Inspection Report

Property Address:
23-4627 Sharp Terrace
Saanich British Columbia

Victoria Home Inspections

Date: 2022-05-13	Time:	Report ID: VHI-3301
Property: 23-4627 Sharp Terrace Saanich British Columbia	Customer: Mr. Quaid King	Real Estate Professional:

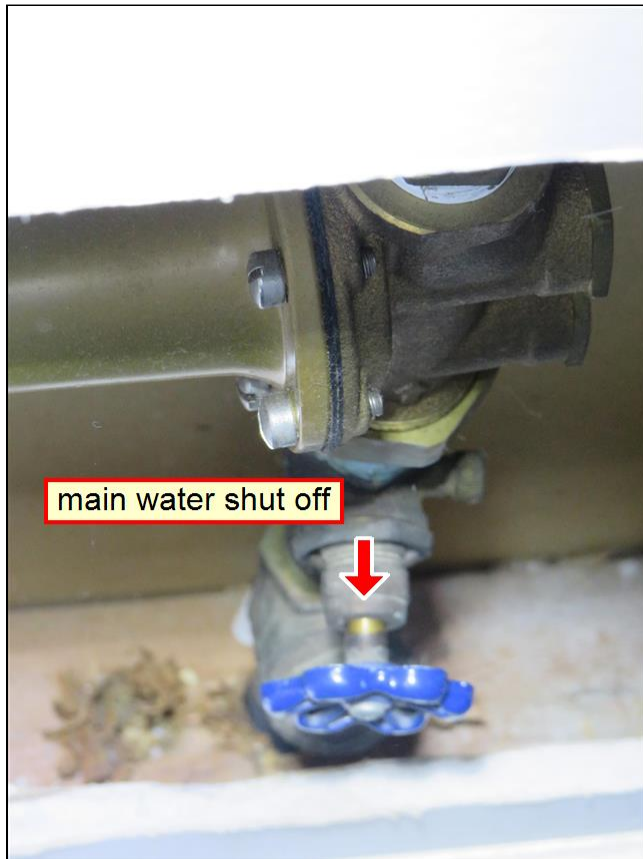
6.3 Item 1(Picture)

The main water shut off is the blue knob located behind the hot water tank. This is for your information.

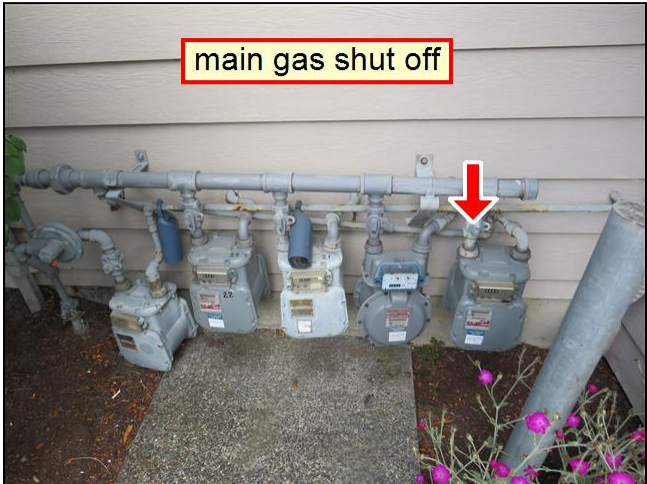
6.5 Item 1(Picture)

The main fuel shut off is at gas meter outside. Confirm with strata the meter is for unit #23. This is for your information.

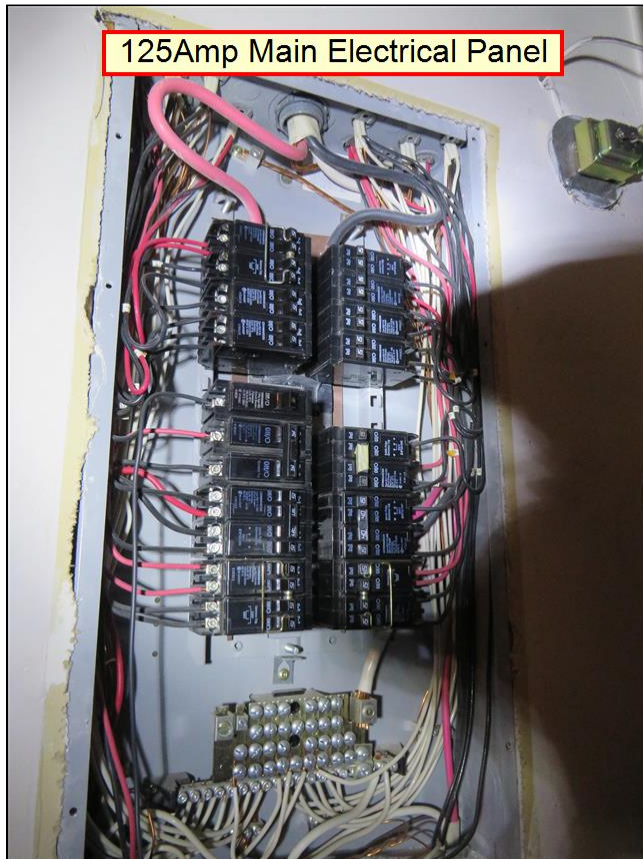
7.6 Item 1(Picture)

The main panel box is located in the garage. This is for your information.
